MARINE SAFETY ALERT

Alert 9-08

ELECTRONICALLY-CONTROLLED CARGO PUMP ENGINE COMPONENTS

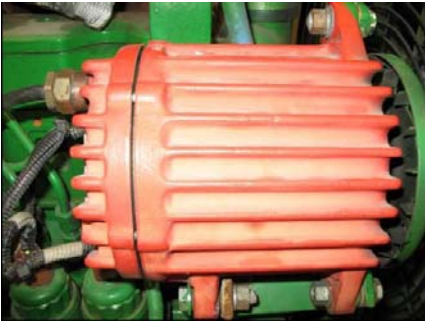
Alternators: If an alternator is used, it should be an approved flameproof or explosion proof alternator.

Typical flame proof /explosion proof alternator.

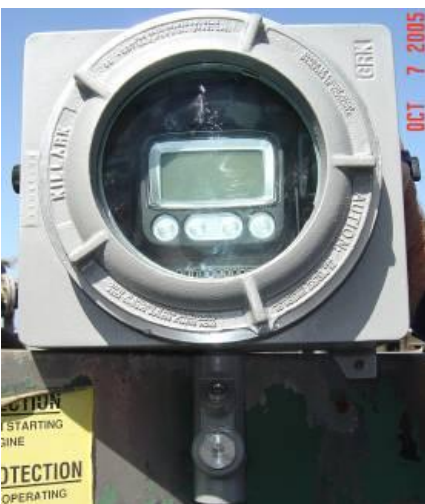
Typical acceptable electronic display – This particular one was approved by the Marine Safety Center (John Deere Part No. RE531478)

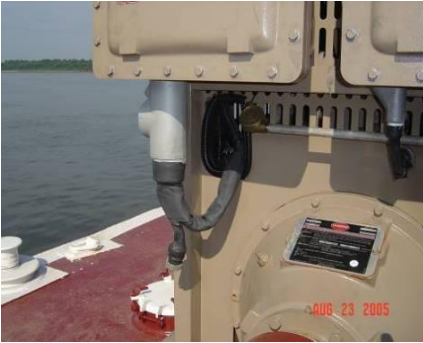
An acceptable engine control unit (ECU) enclosure is shown here with a sealing compound installed in a proper cable gland. Sealing compound poured in the conduit or cable seal fitting should surround each individual insulated conductor and the outer jacket of the cable, unless the cable is gas tight. Cables should be prevented from being pulled out of the conduit or cable seal fitting.

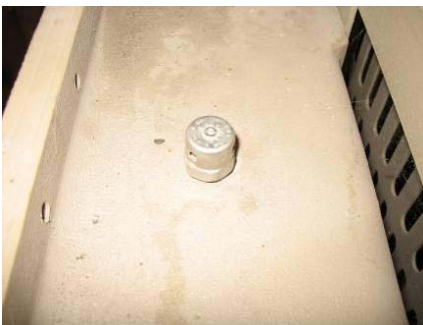
An acceptable battery installation as shown here, approved for this purpose should be the “sealed, gel or AGM” types.

Batteries should be placed in explosion proof enclosures and should have an approved breather installed on top.
